COLORADO CULTURAL RESOURCE SURVEY

Architectural Inventory Form

RECONNAISSANCE LEVEL SURVEY FORM

1. Resource number: 5AH.1179
2. Temporary resource #: N/A
3. County: Arapahoe
4. City: Littleton
5. Historic building name: Reinke Self-Serv Laundry
6. Current building name: Adams Photography, et al
7. Building address: 2555 W Alamo Ave
8. Owner name, address: Cindylou LLC
2555 W Alamo Ave
Littleton, CO 80120-1901

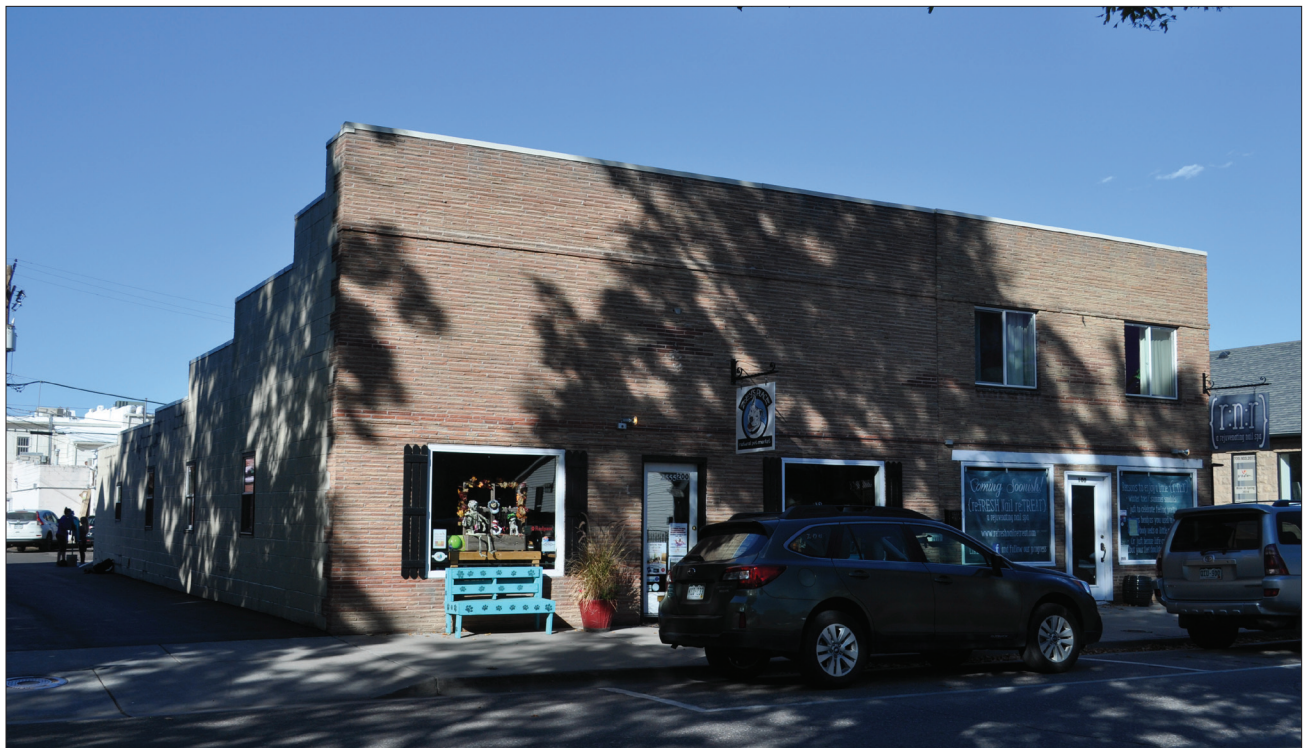
The former Reinke Self Serv Laundry is sited at the center of a rectangular lot just behind the public sidewalk on S Alamo Ave. It appears to be group of three individual structures with shared party walls. Two structures form the south wall/facade of the building. The west structure is one-story in height with a high parapet wall that is level with the roofline of the two-story structure to the east. A third structure, one-story in height, adjoins both buildings to the north and east.

The irregular plan building is one to two-stories in height with flat roofs. It is constructed of roman brick and concrete block masonry with metal and glass windows and doors.

The south wall/facade is running-bond roman brick. Redder brick defines multiple string courses and scattered geometric forms on a ground of a lighter, yellower brick. The ad hoc quality of the patterning indicates that it may just be the result of mismatched brick lots, and that the two buildings may have been faced with brick at different points in time. Metal and glass doors and windows form two storefronts. The east storefront has two windows above, at the second story level.

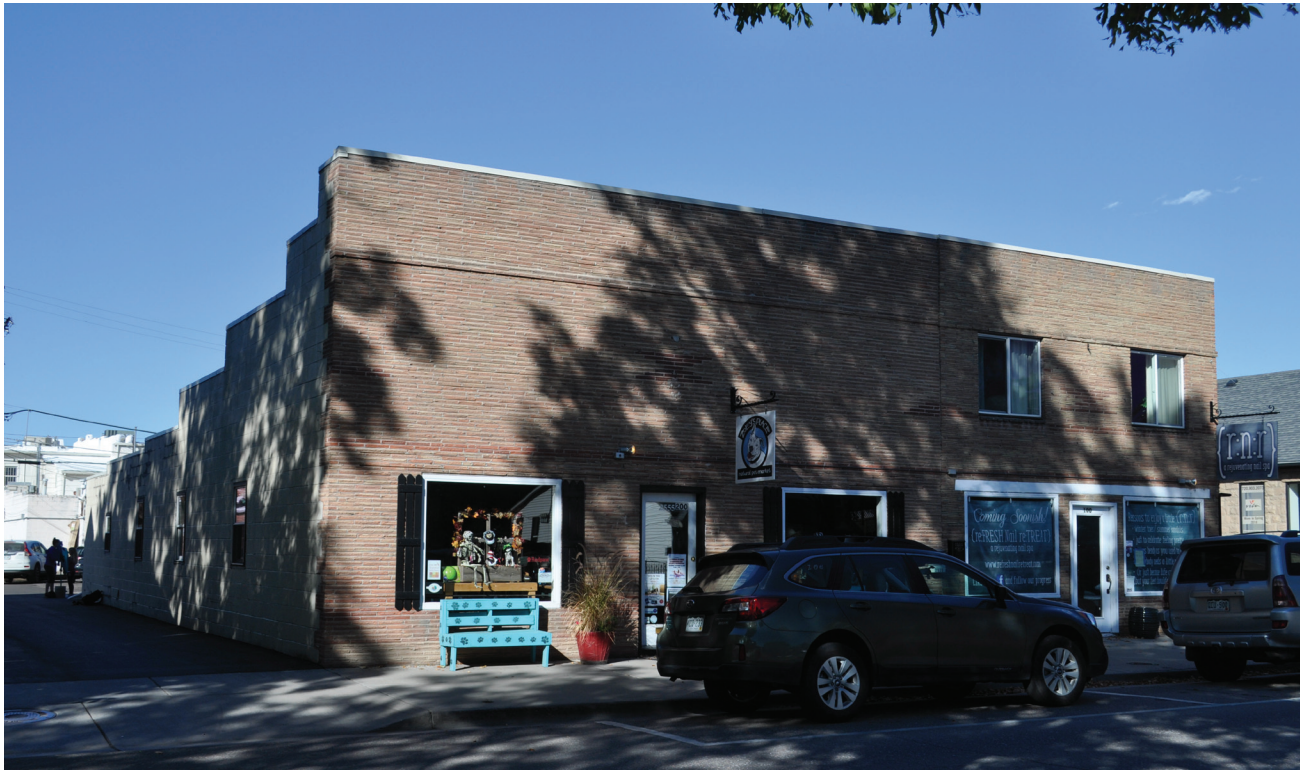
Photo: 2555 WAA 01.jpg
South Wall, facade (right); West Wall (left), W Alamo Ave in foreground.

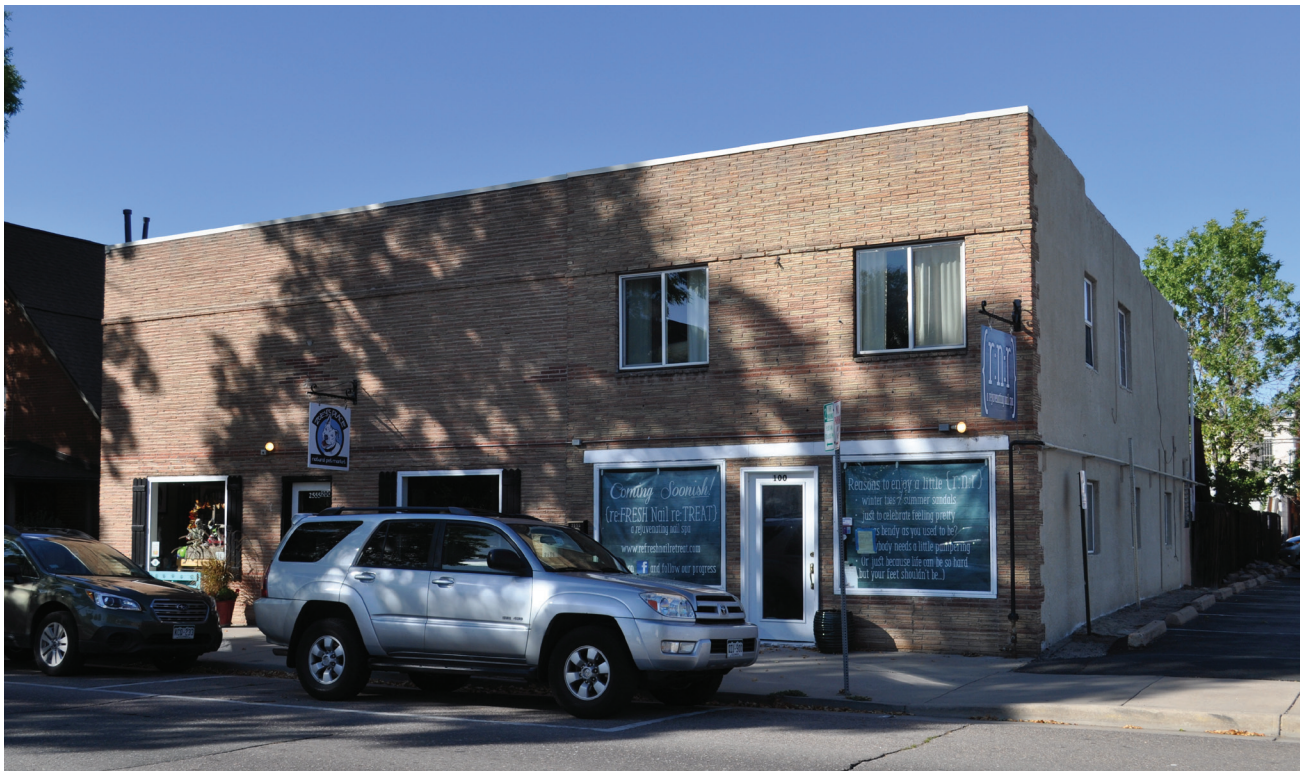
The east, west and north walls are concrete block masonry with scattered windows and service doors to the north.

Photo: 2555 WAA 02.jpg
South Wall, facade (left); East Wall (left), W Alamo Ave in foreground.

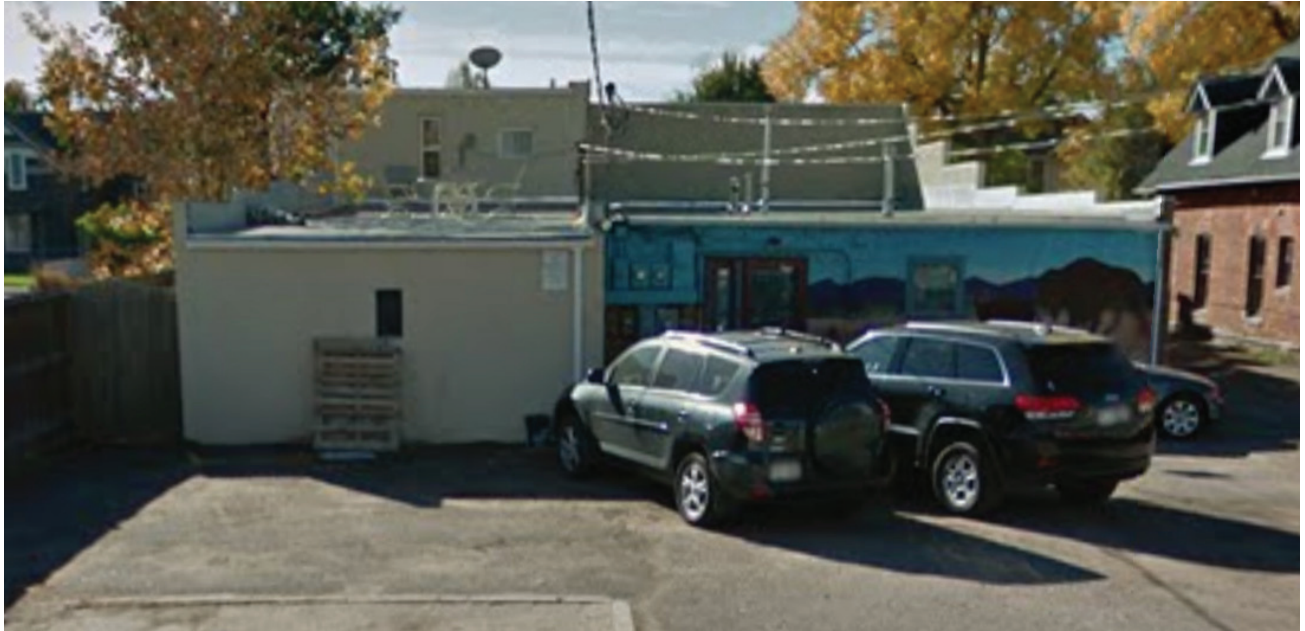
A surface parking lot appears between the rear of the building and the public alley to the north.

Photo: 2555 WAA 03.jpg
North Wall, rear parking lot in foreground.
