COLORADO CULTURAL RESOURCE SURVEY

Architectural Inventory Form

RECONNAISSANCE LEVEL SURVEY FORM

Survey of Commercial Modernism in the West Littleton Boulevard Corridor 1950-1980.

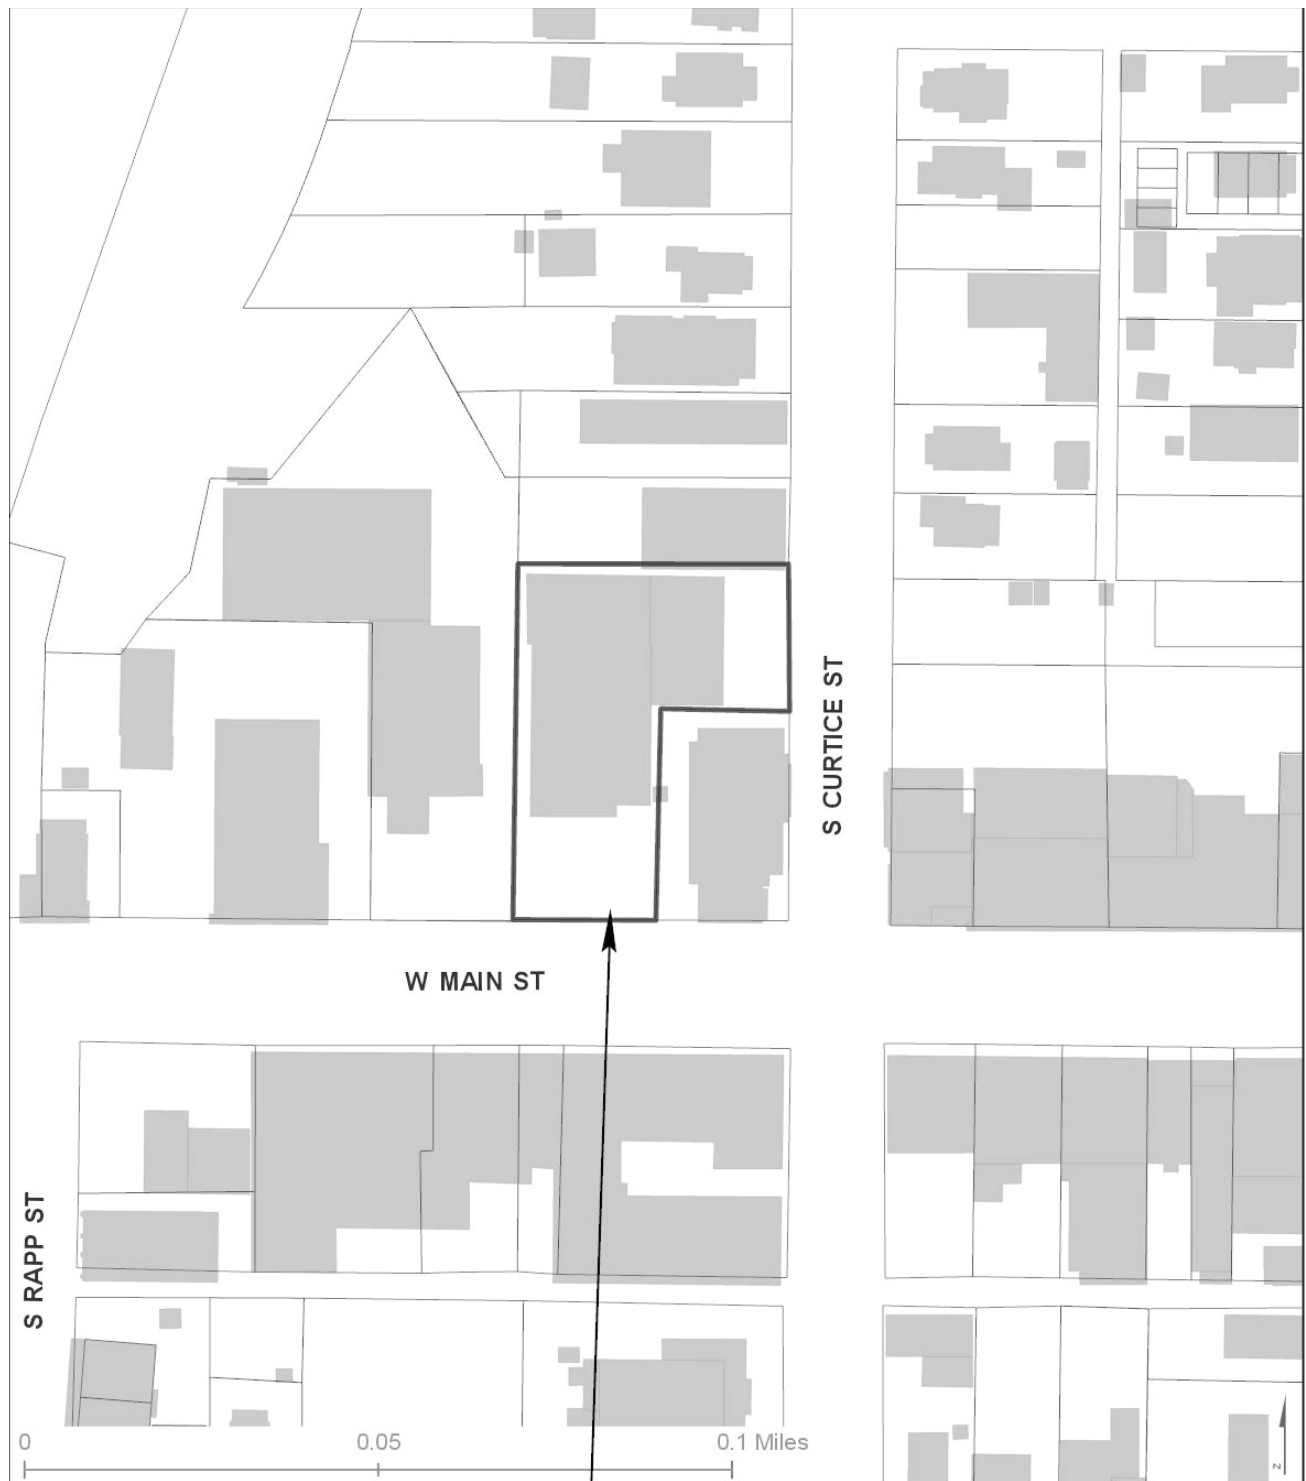
Sketch Map

The former CeBuzz Super Market is sited at the northwest corner of an L-shape lot facing both W Main St and S Curtice St. To the east and south, portions of the building border an L-shape public alley.

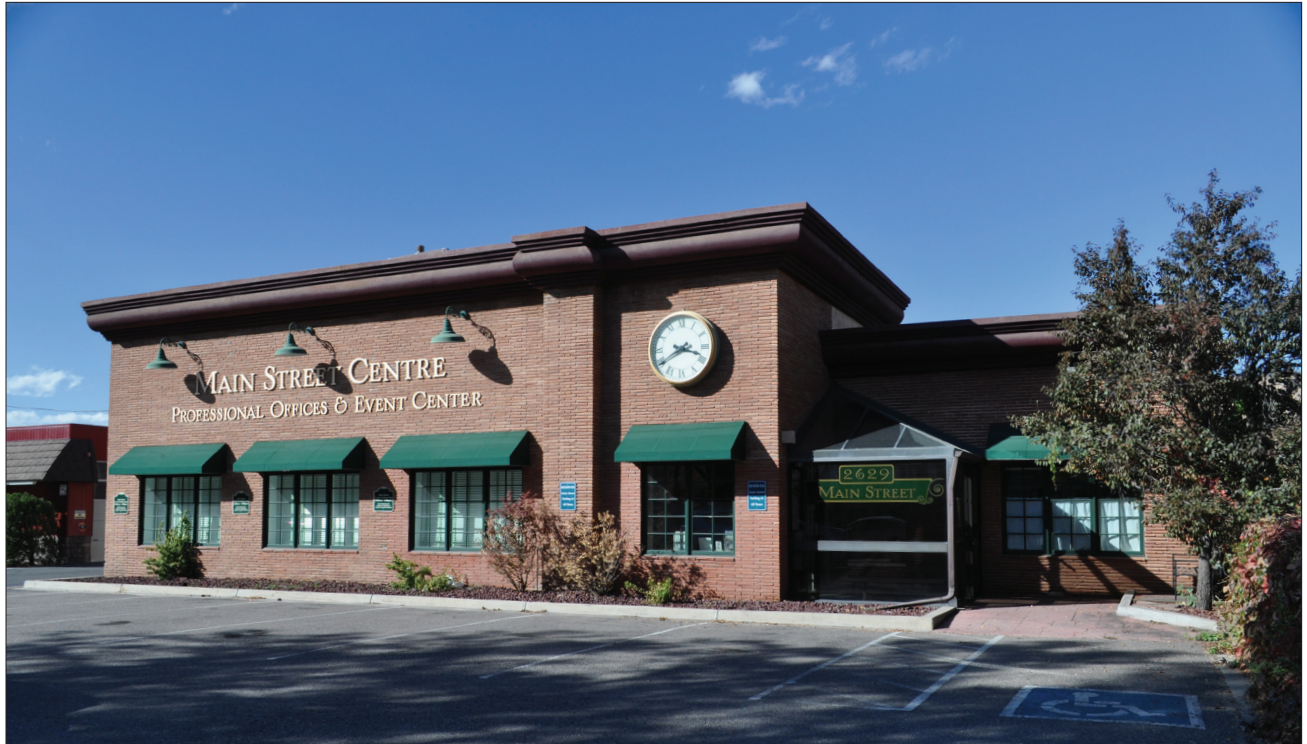
Photo: 2629 WMS 01.jpg
South Wall, facade.

The south wall/facade, facing W Main St, is running-bond roman brick with a single raised pier that runs the height of the building. The west section of the facade displays four multi-pane windows with roman brick sills and canvas awnings. The east section, narrower and lower in height, steps back to the north. The main entrance appears at the intersection of the two sections, within a metal and glass entry hall with pitched roof. To the right is a single window with awing. An exaggerated EIFS roof cornice extends across the face of both sections.
