HISTORIC BUILDING INVENTORY RECORD

PROJECT NAME: Littleton Historic Buildings Survey 1997 (#97-01-082)		COUNTY: Arapahoe	CITY: Littleton	STATE ID NO.: 5AH1288
		TEMPORARY NO.: 2077-17-4-04-011		
CURRENT BUILDING NAME: Red Tiger		OWNER: STEELE, JACK W & DONALD E UND 1/2 INT EACH 4770 S WADSWORTH BLVD LITTLETON CO 80123		
ADDRESS: 2559 W MAIN ST Littleton, CO 80120		TOWNSHIP 5S RANGE 68W SECTION 17 NE 1/4 SE 1/4		
HISTORIC NAME: Lilley Livery Stable		U.S.G.S. QUAD NAME: Littleton, Colo. YEAR: 1965 (r. 1994) X 7.5' 15'		
DISTRICT NAME: Littleton Main Street		BLOCK: 4 LOT(S): 2-5 ADDITION: LILLEY'S RESUB BK 4 YR. OF ADDITION: N/A		
FILM ROLL NO.: 97- 1A BY: Roger Whitacre	NEGATIVE NO.: 13	LOCATION OF NEGATIVES: Littleton Hist. Mus.	DATE OF CONSTRUCTION: ESTIMATE: 1907 ACTUAL: SOURCE: Sanborn Maps

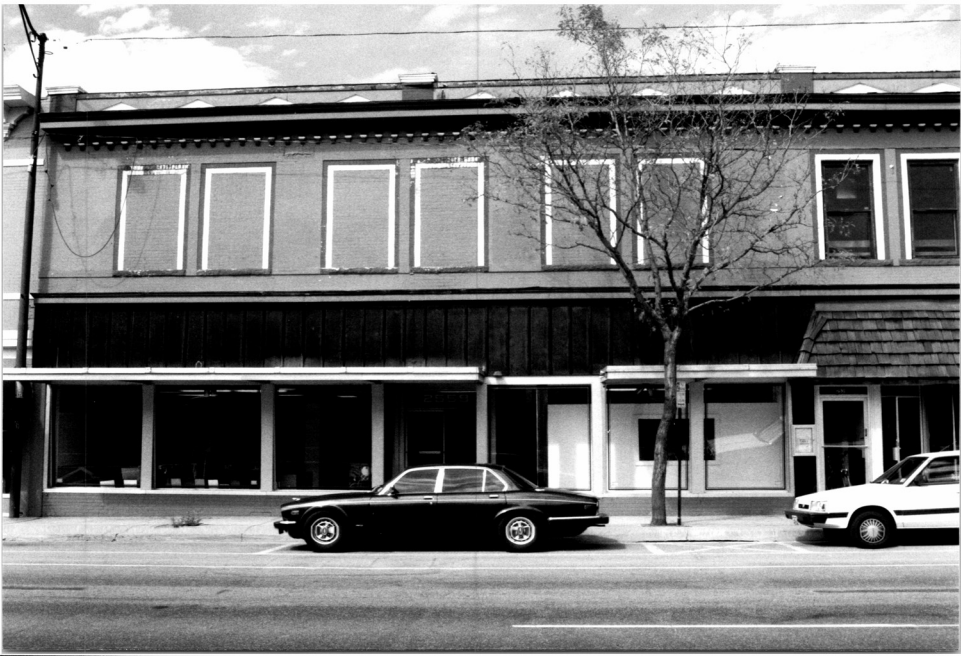
USE: PRESENT: Commercial	
			HISTORIC: Livery Stable	
			CONDITION: EXCELLENT GOOD X FAIR DETERIORATING	
			EXTENT OF ALTERATIONS: MINOR X MODERATE MAJOR DESCRIBE: Altered first story with board and batten siding above windows; angled display windows; metal hood; painted brick. Windows of upper story are bricked in. Finials removed from roof piers. CONTINUED YES X NO

STYLE: Twentieth Century Commercial		STORIES: 2	ORIGINAL SITE X MOVED DATE(S) OF MOVE:	
MATERIALS: Brick, Wood		SQ. FOOTAGE: 18952	NATIONAL REGISTER ELIGIBILITY	
ARCHITECTURAL DESCRIPTION: Two-story rectangular brick commercial building with flat roof; projecting metal cornice with brackets; parapet above cornice with arched ornamentation and piers which project above roof. First story has single storefront with inset entrance with double glazed metal frame doors with transom. Flanking entrance are grouped plate glass display windows set at an angle from top to bottom and with thick metal frames. Projecting flat metal and fiberglass hoods above windows. Painted brick below windows. Windows of second story are bricked over. One-story rear projection clad with vertical metal siding. Long shed roof with metal pole supports above double metal frame glazed doors and band of three large plate windows. Parking on east and northeast. Side gabled outbuilding is concrete block with rolled roofing. CONTINUED? YES X NO			INDIVIDUAL: YES X NO
